External Stress-Corrosion Cracking of a 1.22-m-Diameter Type 316 Stainless Steel Air Valve

Thomas J. Moore,
Jack Telesman,
Allan S. Moore,
Dereck F. Johnson,
and David E. Kuivinen
*Lewis Research Center
Cleveland, Ohio*

Summary

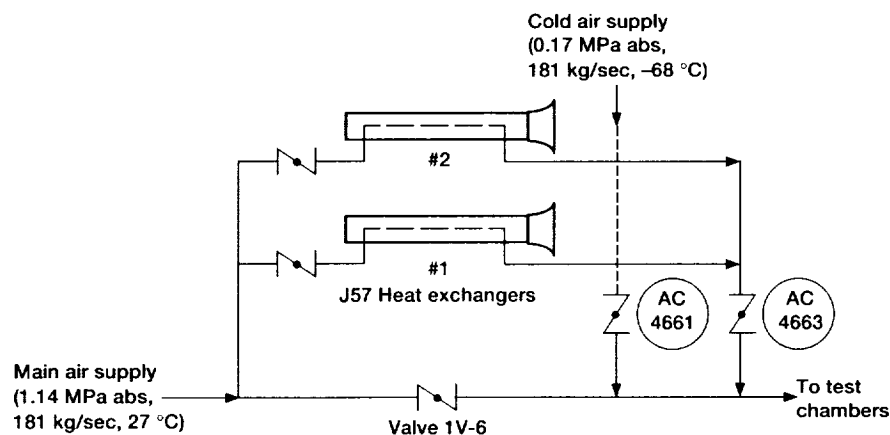
In one mode of operation, ambient combustion air is delivered to the test cell at a maximum delivery rate of 181 kg/sec at 1.14 MPa absolute (fig. 2). In another mode, ambient combustion air is blended with air chilled to -68°C . This chilled air is discharged from valve AC4661 at 181 kg/sec at 0.17 MPa absolute. In a third mode, valve 1V-6 can be used to divert ambient combustion air through the J57 heat exchangers (where nonvitiated air can be heated to 400°C). This heated air is then discharged through valve AC4663 and is mixed with ambient air. In the highest operating temperature variation of the third mode, valve 1V-6 is closed. As seen in figure 2, all of the combustion air is forced through the heat exchangers. The air temperature at the upstream face of valve 1V-6 is at about 27°C and at the downstream face is from 340 to 370°C . The high-temperature mode of operation was used in about 20 of the 100 annual runs made over the past 18 years. In a typical run, the time at the maximum operating temperature was about 3 hr, and the pressure on the upstream face of the valve (about 1.14 MPa abs) was only slightly higher than the pressure on the downstream face.

Figure 2.—Piping for the combustion air supply system.

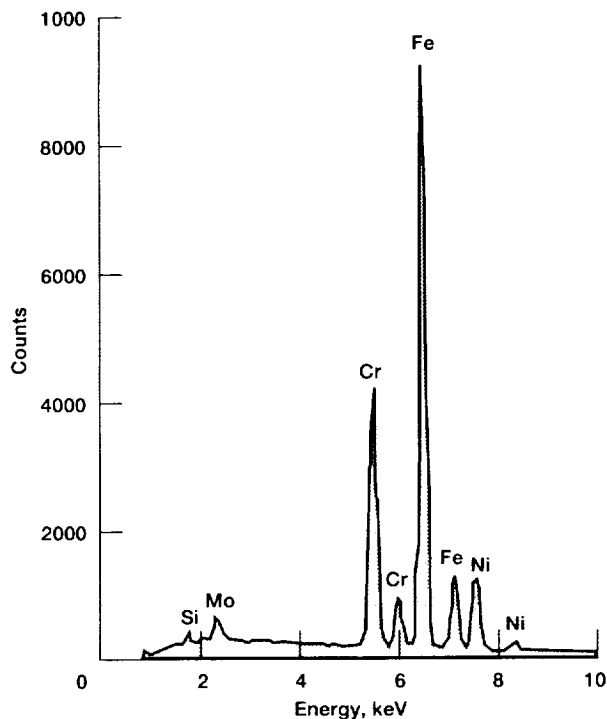
The base metal support ring spectra are shown in figure 15. A comparison of the support ring analysis as determined by XEDS and conventional methods can be made using the data in table I. This comparison shows general agreement except for the lower molybdenum (Mo) content in the XEDS analysis.

Figure 15.—Type 316 stainless steel matrix spectra.
